Hull Waste Water

Atlantic, Ocean

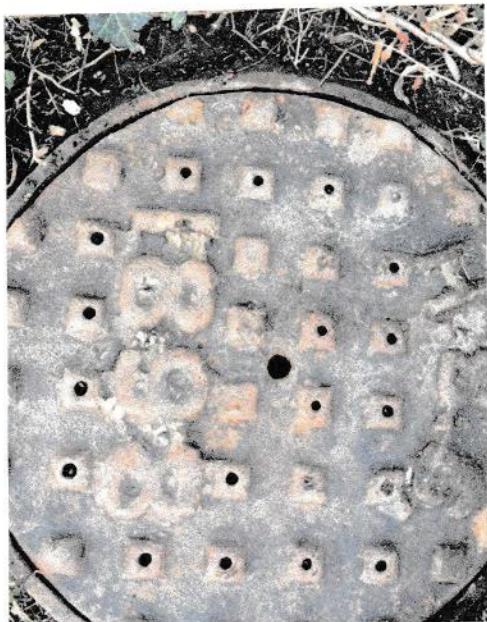
#1 #76 FOUNDATION

#2 DOWNSTREAM MANHOLE

"Looking up towards area
where SSO had occurred."

#3 Looking FROM MANHOLE
TOWARDS ATLANTIC AVE
#76 is to the right.
